A1	Trouble-shooting program	
-----------	--------------------------	--

Special features, test specifications
Opel

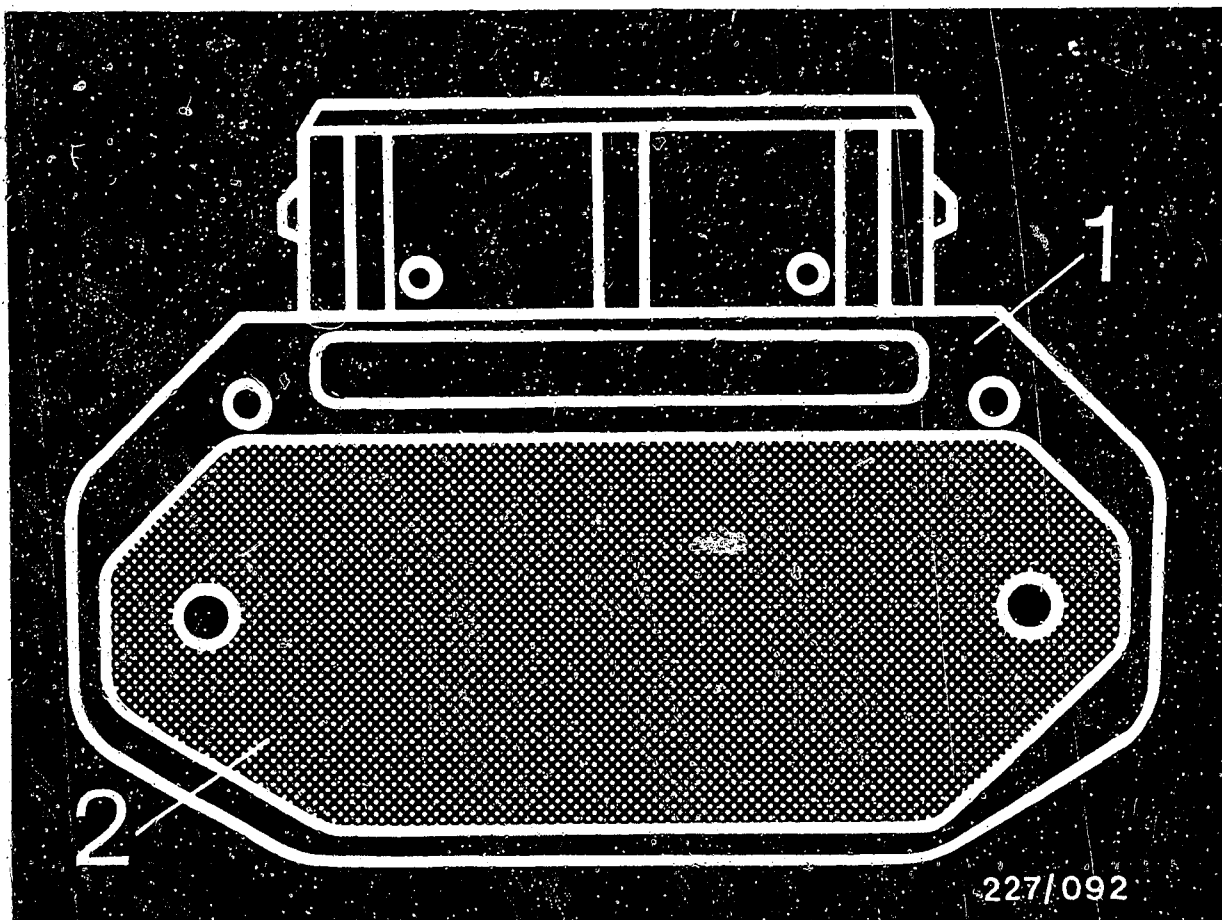
1 = Trigger box

2 = Base plate

- Before mounting the trigger box, the base plate must be coated with thermal conduction paste. Apply thermal conduction paste only with a suitable object (screwdriver, matchstick etc.)

Do not apply thermal conduction paste to painted parts.

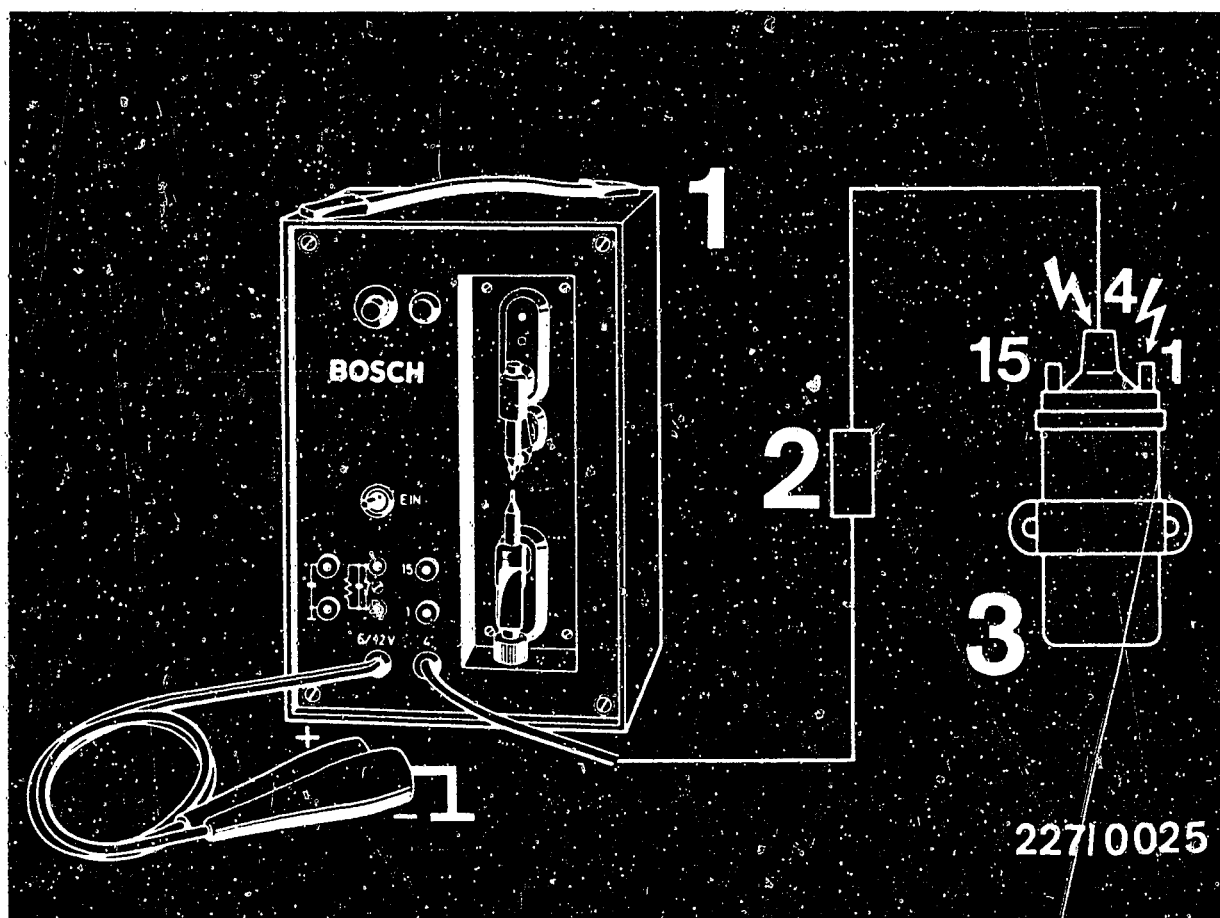
- 1 = Spark gap
- 2 = 5 kΩ sleeve-type suppressor
- 3 = Ignition coil

- In order to prevent the trigger box from being irreparably damaged, when using a spark gap, an interference-suppression resistor of at least 2 kΩ must be connected between the spark gap and ignition coil terminal 4, e. g. sleeve-type suppressor (5 kΩ) 0 356 500 001.

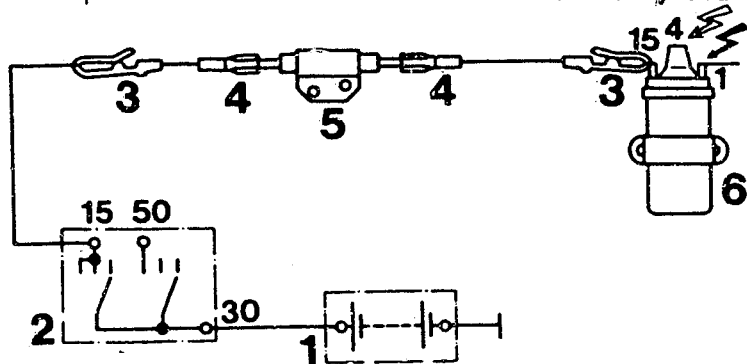
In comparison with conventional ignition systems, transistorized ignition systems with current limitation have different primary voltage characteristics. During the dwell period the voltage at terminal 1 of the ignition coil may assume values from 1.5 V to battery voltage (or greater). This may lead to an incorrect display of rotational speed and dwell angle when testing the ignition system. However, there is no functional defect in the ignition system, and, for this reason, the trigger box must not be replaced. Incorrect displays may occur with the testers listed below:

Connect a ballast resistor of 0.9 or 1.0 Ohm (see Fig.) in series in the line to term. 15 of the ignition coil (take care not to cause a short circuit). After the rotational-speed measurement, the ballast resistor must be removed (otherwise starting difficulties and misfiring). Connect tester as per operating instructions.

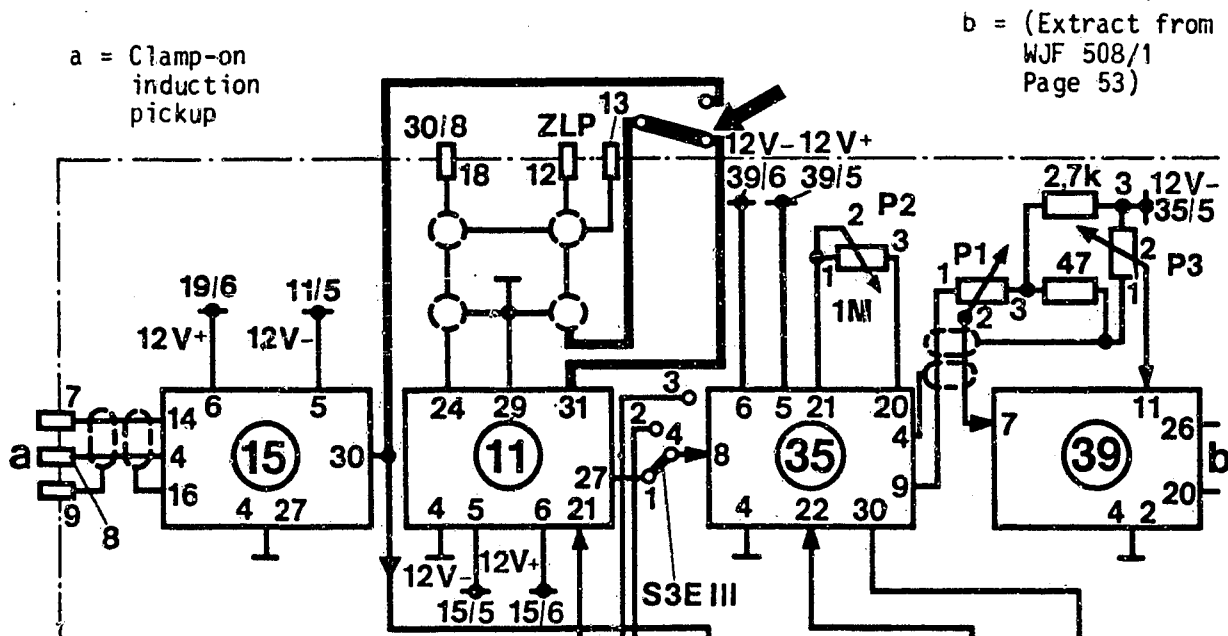
In comparison with conventional ignition systems, transistorized ignition systems with current limitation have different primary voltage characteristics. During the dwell period the voltage at terminal 1 of the ignition coil may assume values from 1.5 V to battery voltage (or greater). This may lead to an incorrect display of rotational speed and dwell angle as well as to incorrect triggering of the meter when testing the ignition system. There is, however, no functional defect in the ignition system, and, for this reason, the trigger box must not be replaced. Since, with the above-listed motortesters, the timing light is triggered by the signal path dwell angle - meter, this incorrect triggering also leads to incorrect flashing and thus to an incorrect display of the advance angle.

Remove the line of the ZLP* from pin 31 of printed board 11 (coupling stage) and connect to pin 30 of printed board 15 (pulse shaper stage) via a switch with change-over contact (e.g. 0 341 500 803). In addition, a new line must be connected from pin 31 of printed board 11 to the other contact of the switch with change-over contact. Arrow points to switch with change-over contact.
